REPORT OF INVESTIGATION

Fatal Powered Haulage Accident  
February 10, 2004

Cucumber Mine  
Raw Coal Mining Company, Inc.  
Cucumber, McDowell County, West Virginia  
ID No. 46-08580

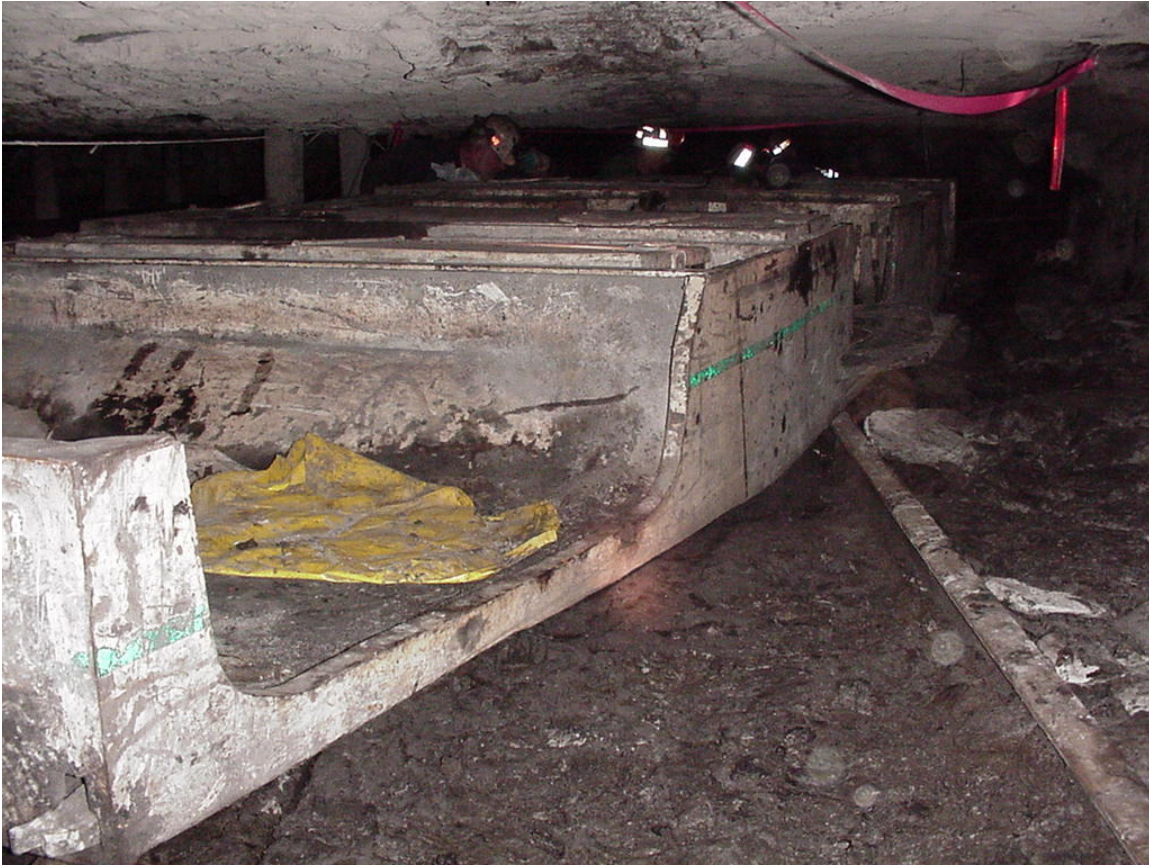
At approximately 7:35 a.m. on Tuesday, February 10, 2004, a 25-year old roof bolting machine operator with 7 years of mining experience was fatally injured at Raw Coal Mining Company, Inc.'s Cucumber Mine. The accident occurred while the victim, Gary Shannon Addair, was operating an open-type, battery-powered, track-mounted personnel carrier. The personnel carrier entered the track portal, through an open airlock door, and continued to gain speed as it traveled down an 8 to 21 percent grade on damp to wet rails for approximately 139 feet before striking the closed inby airlock door. Addair received fatal injuries when struck by the inby door. The mantrip then traveled approximately 320 feet before derailling.

The personnel carrier was operated at a speed that was inconsistent with track and equipment conditions, and was not controlled so that it could be stopped before striking the inby, closed, airlock door. An inoperable sanding device likely reduced the braking capacity on the personnel carrier at the time of the accident.
